Ocean Tree Condominium

3400 N Ocean Drive

Phase One Milestone Inspection

PHASE ONE MILESTONE INSPECTION AND RESERVE STUDY

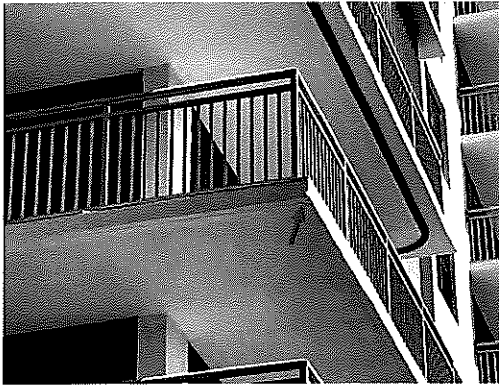
Item 1.o.1

1. Cracks on several balconies edge slab at S/E, N/E at several levels.

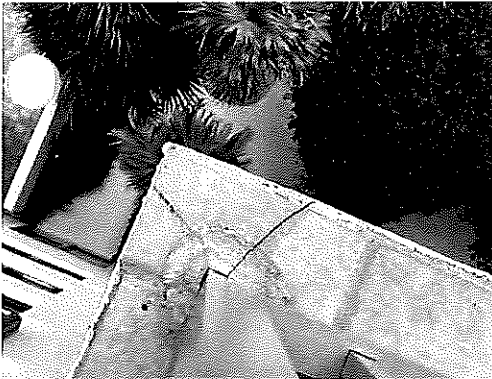
Item 1.o.4

4. Stucco cracks at the 11 and 14 floor S/W balcony North corner.

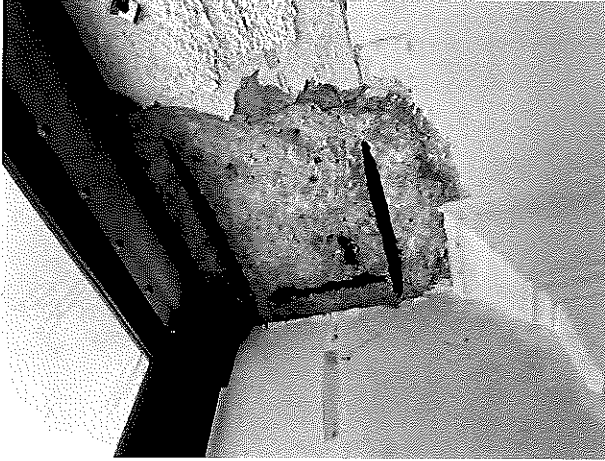
Item 1.o.9

9. Few tiles are being replaced in Unit 1808 and minor water damage at wall is also being repaired. In addition, the west edges of balcony exhibit minor cracks at corner of slab.
